U. S. Department of Agriculture  
FOREST SERVICE

Shippewa NATIONAL FOREST 213-4  
CORNERS OF THE PUBLIC SURVEY

T. 58-57 R. 26 4th Mer.

Meander Corner common to Sections  
3, and 34

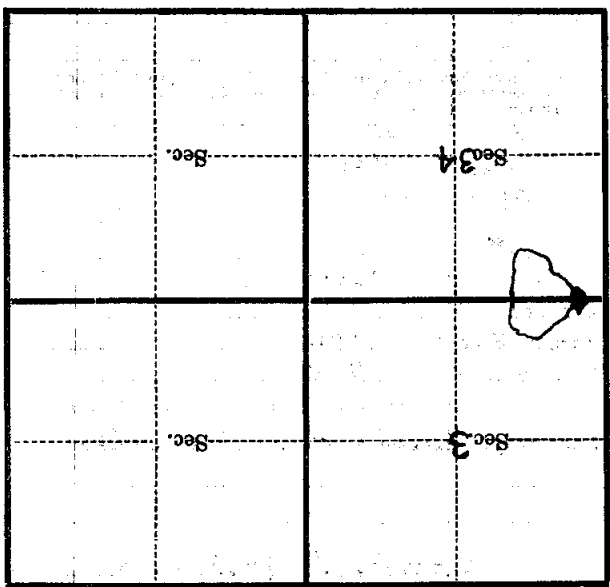
(Make sketch of topography near Corner)

Tamarack 131  
is broken off and leans  
against cedar  
Another metal location poster is  
on 5 inch wh. cedar 8 ft in which  
corner bears N 39° E 54 KS

.07 chains distant.

from which this Corner bears 978 E

side of tree

tree 8 inches diameter, on the East

Metal Location Poster is on a wht. cedar
