U. S. Department of Agriculture  
FOREST SERVICE

Chippewa NATIONAL FOREST

CORNERS OF THE PUBLIC SURVEY

T. 141-142 R. 30 5 Mer.

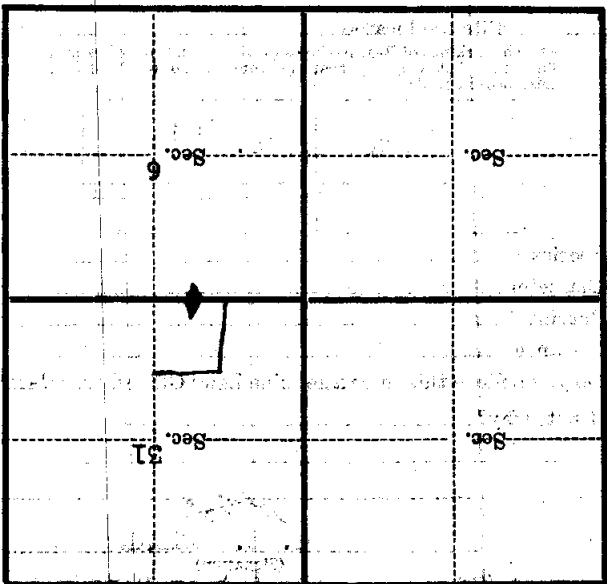
Corner consists of a 1" iron pipe w/brass cap. in place

State condition Good

Dimensions above ground 2 inches

Corner is in center of road bed.  
Corner again.
