FOREST SERVICE

CHIPPEWA NATIONAL FOREST

CORNERS OF THE PUBLIC SURVEY

Corner common to Sections
(31) and 6

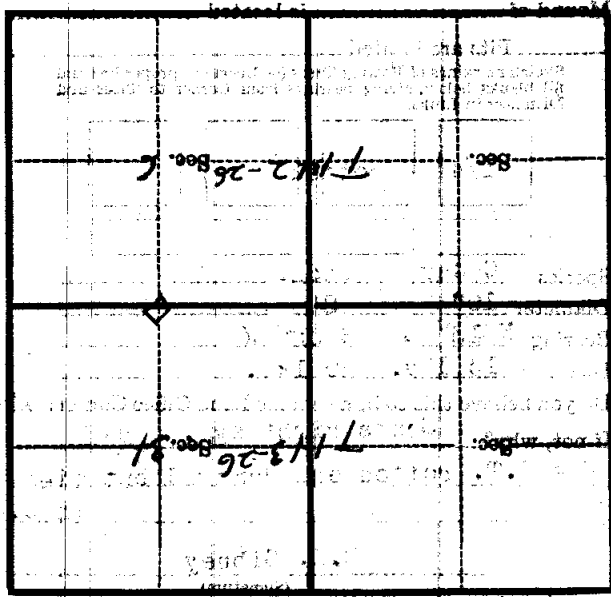
(Make sketch of topography near Corner)

Corner again.
Gadar swamp. Old cuttings around corner
& chains along town line east of lake.
