U. S. Department of Agriculture

Chippewa NATIONAL FOREST

CORNERS OF THE PUBLIC SURVEY

T. 144N R. 31W 5th Mer.

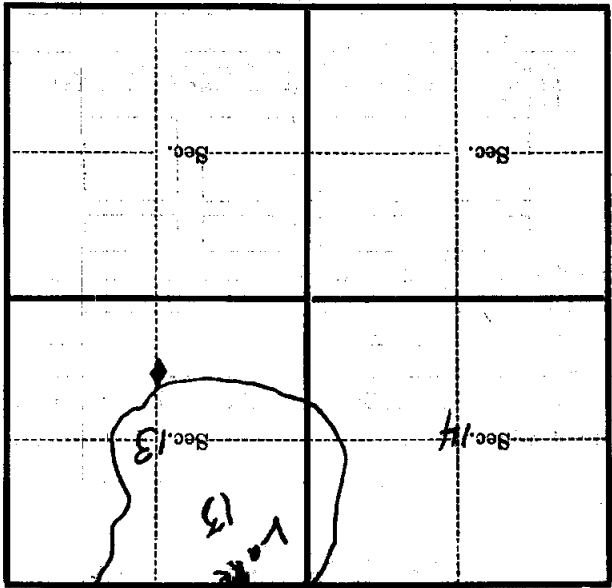
(Make sketch of topography near Corner)
