U. S. Department of Agriculture  
FOREST SERVICE

*Chippewa* NATIONAL FOREST

CORNERS OF THE PUBLIC SURVEY

*1/4* Corner common to Sections *25*, and *36*

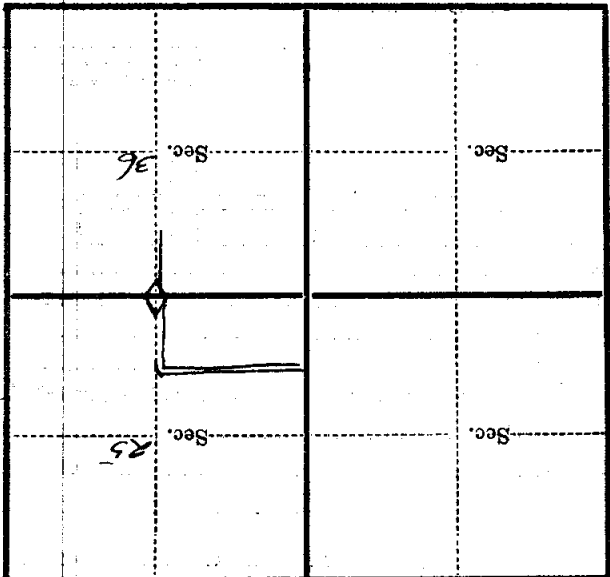
from which this Corner bears *due west*

side of *road*

(Make sketch of topography near Corner)
