CERTIFICATE OF LOCATION OF GOVERNMENT CORNER

NORTH SIXTEENTH Corner of Section 11 & 12, Township 142, Range 31, 5th P.M.

STATE OF MINNESOTA, County of CASS

DOCUMENT NO. 261361

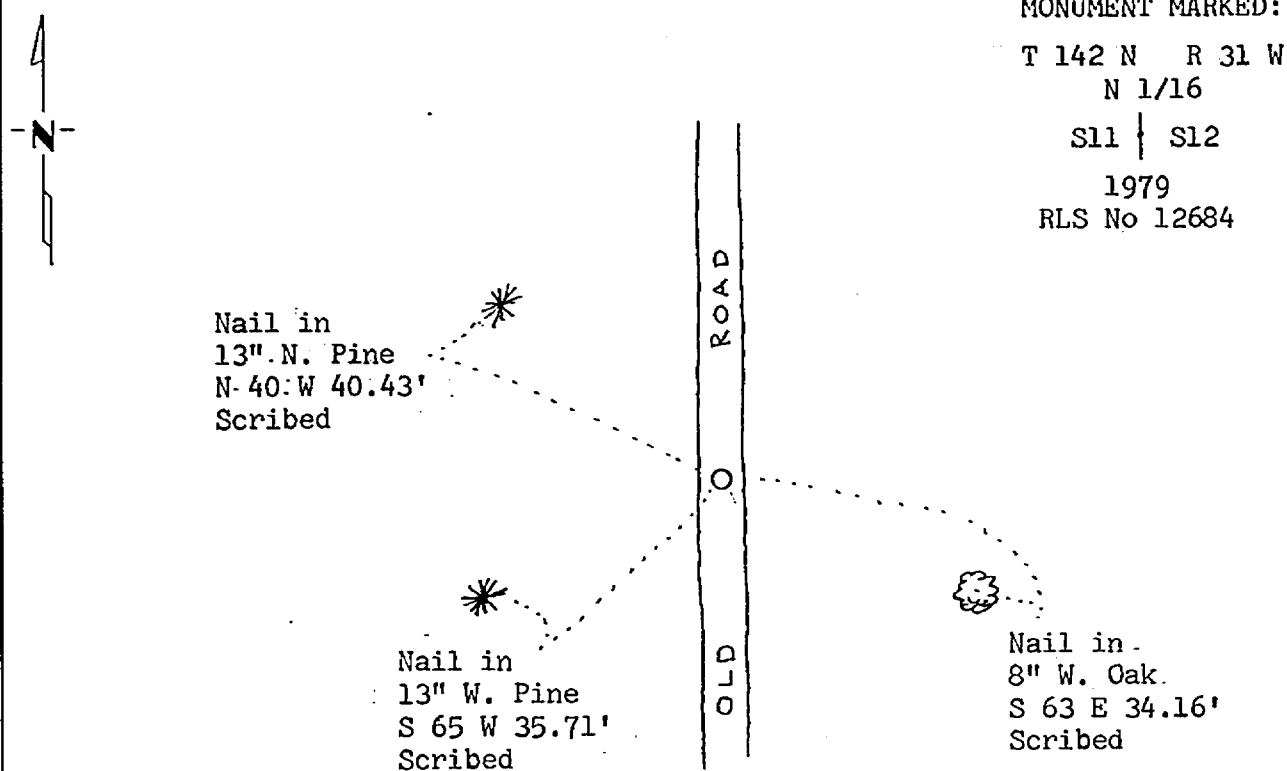
SKETCH OF REFERENCE TIES

- On 12/11/79 found a bent iron pipe as set by the GLO in 1917 with brass cap missing.
DATE
- left monument as found, lowered monument, removed monument (explain)
- On 12/11/79 placed a 2" x 24" concrete filled galvanized iron pipe with marked brass cap down 6".
DATE

BEARINGS ARE APPROXIMATE
