Chippewa NATIONAL FOREST

CORNERS OF THE PUBLIC SURVEY

T. 19 N. R. 29 W. 5th Mer. Section Corner common to Sections

28, 29, 32, and 33

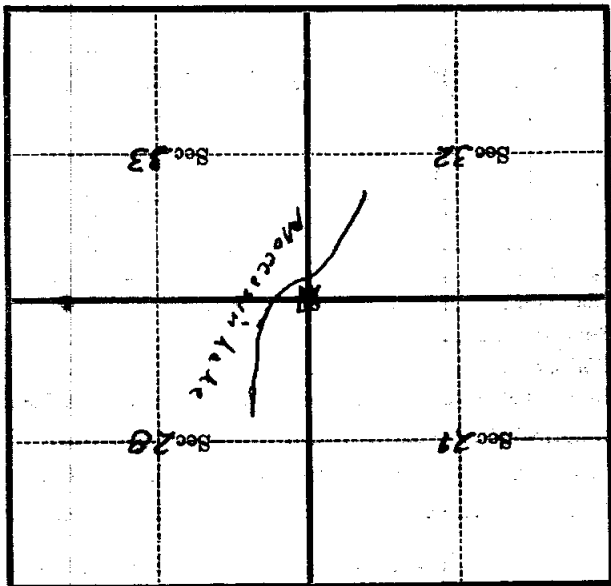
Line are cut NW from this  
corner which is 2 ch. N. and  
9 ch. W. of Meccasin Lake
