FOREST SERVICE

*Wipac* NATIONAL FOREST *Posted 51-2*

CORNERS OF THE PUBLIC SURVEY

T. 141 R. 31 Mer. 5

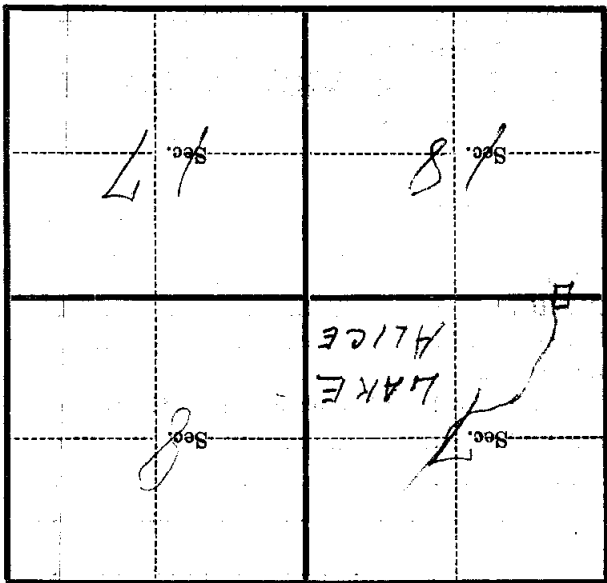
(Make sketch of topography near Corner)

Corner again.  
THIS CORNER NOW 125'  
LINKS FROM WATER'S EDGE  
ON WEST SIDE OF LAKE ALICE  
ON SEC. LINE BETWEEN T AND  
18

Metal Location Poster is on a N ASPEN  
tree 4 inches diameter, on the NORTH  
side of MEANDER CORNER  
from which this Corner bears  
383 LINKS chains distant.  
Give any further facts which will aid in finding this
