U. S. Department of Agriculture
FOREST SERVICE

CHIPPEWA NATIONAL FOREST

CORNERS OF THE PUBLIC SURVEY

T. 142 R. 26 5 Mer.
Section _____ Corner common to Sections

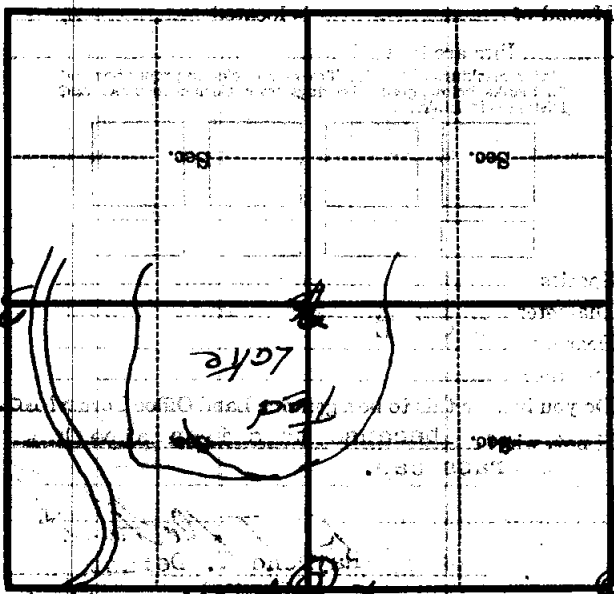
(Make sketch of topography near corner)

chain distant.

14

from which this Corner bears North

side of Cedar Snag

tree 12 inches diameter, on the North

Metal Location Post is on a Cedar Snag
