U. S. Department of Agriculture  
FOREST SERVICE

*Chippewa* NATIONAL FOREST

CORNERS OF THE PUBLIC SURVEY

T. *144 N* R. *36 W* *5th* Mer.

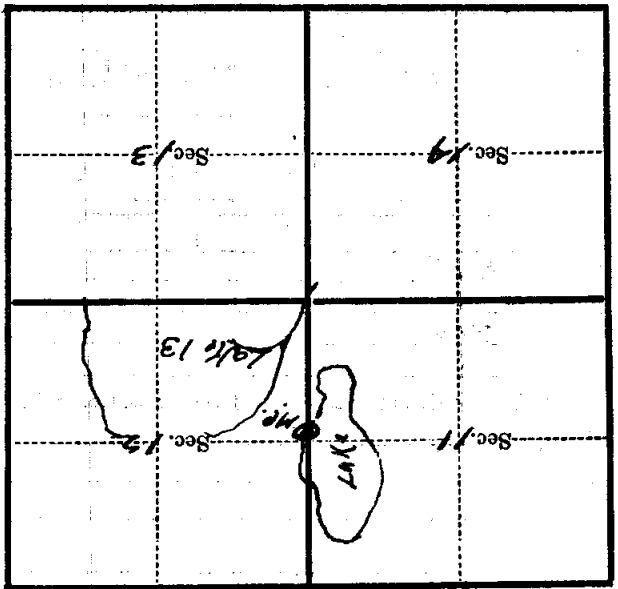
Metal Location Poster is on a tree ..... inches diameter, on the side of ..... from which this Corner bears ..... chains distant.  
 Give any further facts which will aid in finding this Corner again.
