U. S. Department of Agriculture
FOREST SERVICE

NATIONAL FOREST

CORNERS OF THE PUBLIC SURVEY

2 Corner common to Sections
34 T146R26, and 3-T145R26

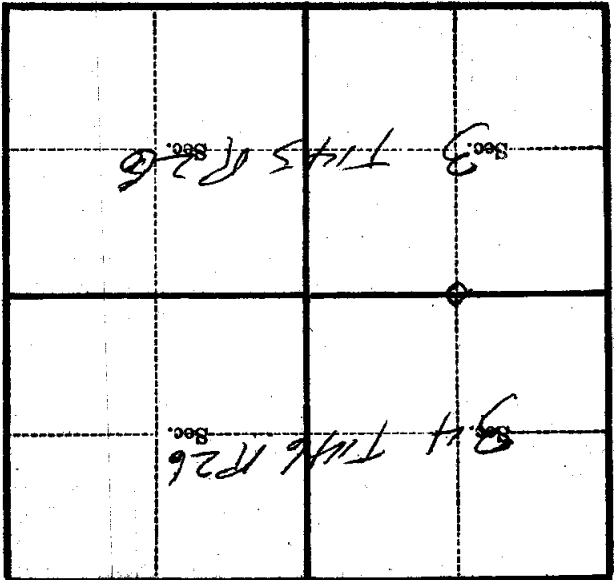
Corner consists of a Iron Pipe - with (not) in place
Aluminum Cap State condition Good

Dimensions above ground 24" inches

Corner again.
 Roof on sec. 14. line. Pipe is
 41' south of road. There is
 space beneath ready for road
 corner & pipe is visible south
 of road. Pipe stamped
