U. S. Department of Agriculture
FOREST SERVICE

Chippewa NATIONAL FOREST

CORNERS OF THE PUBLIC SURVEY

T. 150N R. 28W 6th P. Mer.

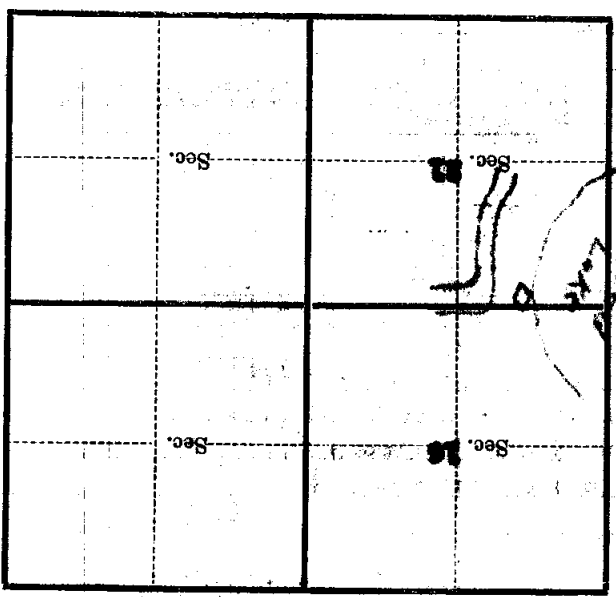
Corner consists of a iron pipe (____) in place
State condition good

Corner again.
Corner is on edge of Island Lake with a banded line extending S chains east from the corner to the County road.

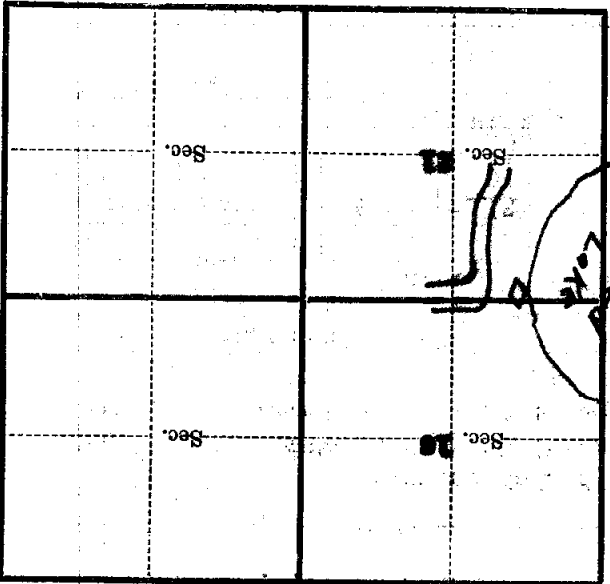
Corner consists of a iron pipe (~~rod~~) in place
State condition good

Corner is on edge of Island Lake with a brushed line extending 5 chains east from the corner to the County road. Corner again.
