CORNER
RESTORATION

T141N R27W

CORNER RESTORATION 141-27

CASS COUNTY, MN USFS

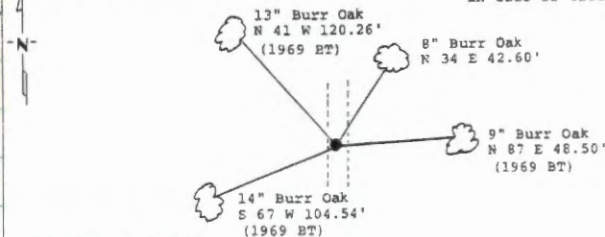
- On 6-20-88 found a Concrete monument with brass tablet (USFS)
 left monument as found, lowered monument, removed monument (explain)
 On _____ DATE _____ placed a _____

Monument is located
in township road
18" under surface of
gravel set 3/8"x12"
Rerod over monument with
Cap #17008
8" sign post East 20.0'

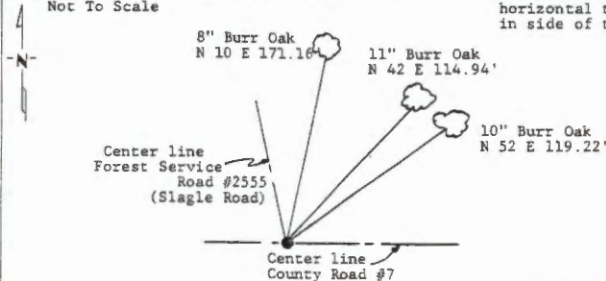
- On 5/13/88 found a railroad spike set over monument U.S. Forest Service position. A 6" x 24" concrete monument (USFS)
 left monument as found, lowered monument, removed monument (explain)
- On _____ placed a _____

Monument is located
in center line of County
Road #7 and centerline
of Forest Service Road #2555
Sign post N 22 E 57.36'

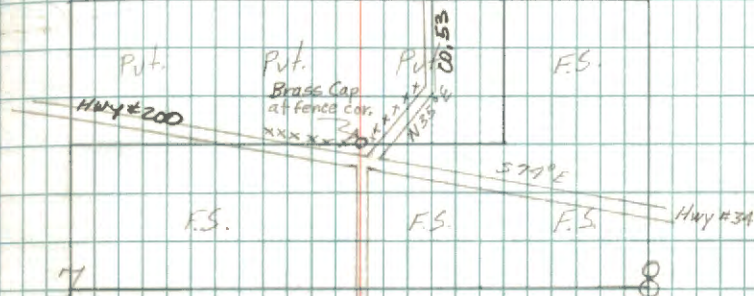
GLO REMOVED BY PHONE COMPANY. Fd PIPE & CAP OUT OF PLACE.
RESET NEW 2" X 2" PIPE W/ 3" CAP FROM B.T.S. & GLO FLANGE. 6' SIGN
POST SHEARED OFF BY SAME, BUT FOUND BASE. IRON IS 55" NORTH
OF #200 IN THE BOTTOM OF DITCH. TREATED WOOD POST W/ TELEPHONE
WARNING SIGN N41°E 48.24' TO #16 NAIL STEEL SIGN POST N66W 9.55'
DIALED 3 ROCKS AROUND CAP OF NEW MONUMENT.
9-6-93 CRK-RM CAP IS 3" BELOW GROUND
MAGNETIC PELLET 36" BELOW SURFACE
BRASS CAP IS BROKEN OFF IRON - IRON IS IN PLACE

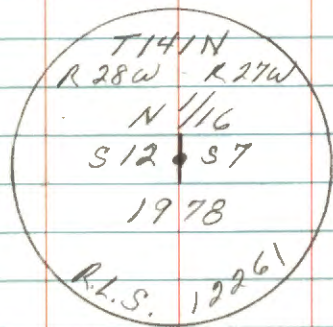
PLACED ON LINE & MIDPOINT
BETWEEN 1/4 CORNER SOUTH &
SECTION CORNER NORTH. POSITION
DETERMINED BY SURVEY OF
THIS RANGE LINE, JUNE, 1978
BY THE FOREST SERVICE.

POSITION MONUMENTED BY PLACING
A 6" X 6" X 24" CONCRETE POST
18" BELOW THE SURFACE OF
THIS ROAD, WITH BRASS CAPPED
AS FOLLOWS:
