T. 143 R. 27 M. 5TH Coordinates: X _____ Y _____
NE 28 Corner common to sections 21, 22, 27, 28

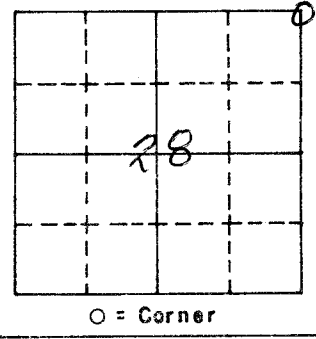
Set a 2" x 24" galv. steel pipe w/ brass cap, on E, below surface.

Steel Sign Post, N3°E, 10.83'

<u>Ash</u>	<u>Ash</u>	<u>Aspen</u>	<u>Aspen</u>
<u>7"</u>	<u>5"</u>	<u>8"</u>	<u>5"</u>
<u>S26W</u>	<u>N33°E</u>	<u>S72°E</u>	<u>N52°W</u>
<u>13.27'</u>	<u>51.25'</u>	<u>34.64'</u>	<u>30.29'</u>
