U. S. DEPARTMENT OF AGRICULTURE
FOREST SERVICE

Chippewa NATIONAL FOREST

CORNERS OF THE PUBLIC SURVEY

T. 145 N R. 27 W 5 Mer.

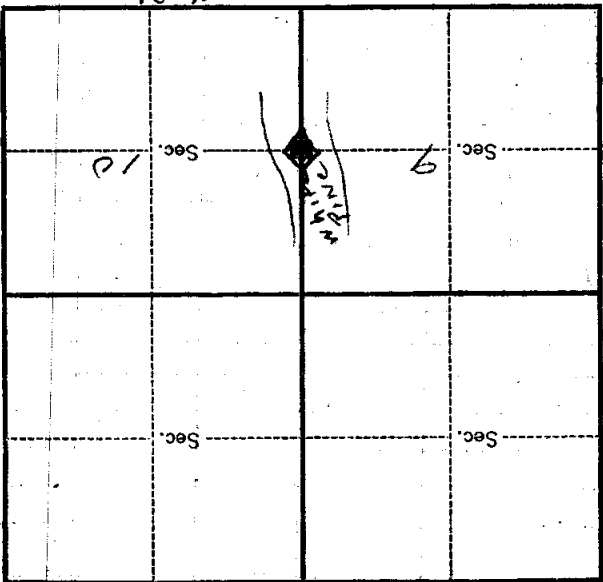
(Make sketch of topography near corner.)

Give any further facts which will aid in finding this Corner again.
 In a Stand of white pine reproduction.
 Near Pine B.T.'s dead.

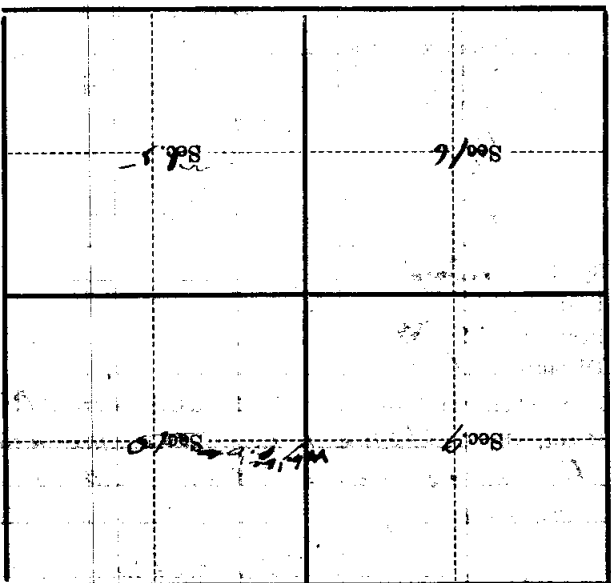
Corner again.
Norway Bearing tree
Peak

(Make sketch of topography near Corner)
