TURNER
RESTORATION

MINING
TRANSIT BOOK

TURNER
RESTORATION
T 146N R29W

Notes of GLO Dependent Resurvey of
 - Surveyor Hal. D. Craig.
 June 21, 1934 to Sept. 19, 1935

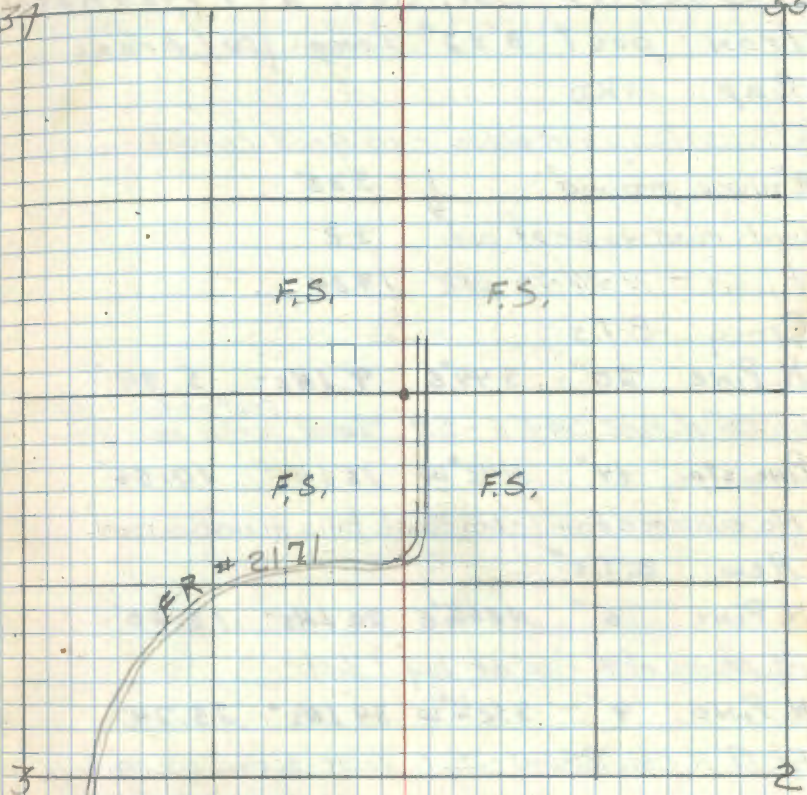
9/17/90 CR, GB

Found GLO concrete cylinder slightly leaning in the swamp.
 Found remains of GLO BT's recorded in 1934:

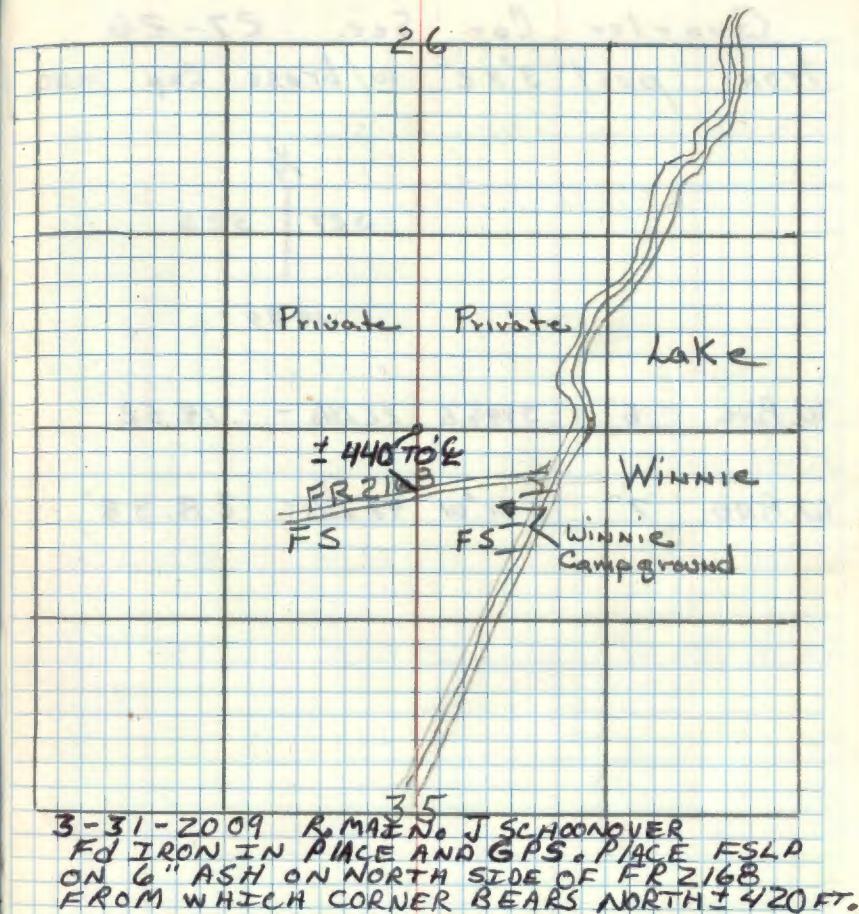
Quarter Cor. Sec. 27-26
 Iron post 3'x2" w/brass Cap MKD.

$\frac{1}{4}$
 527 | 526
 |
 1934

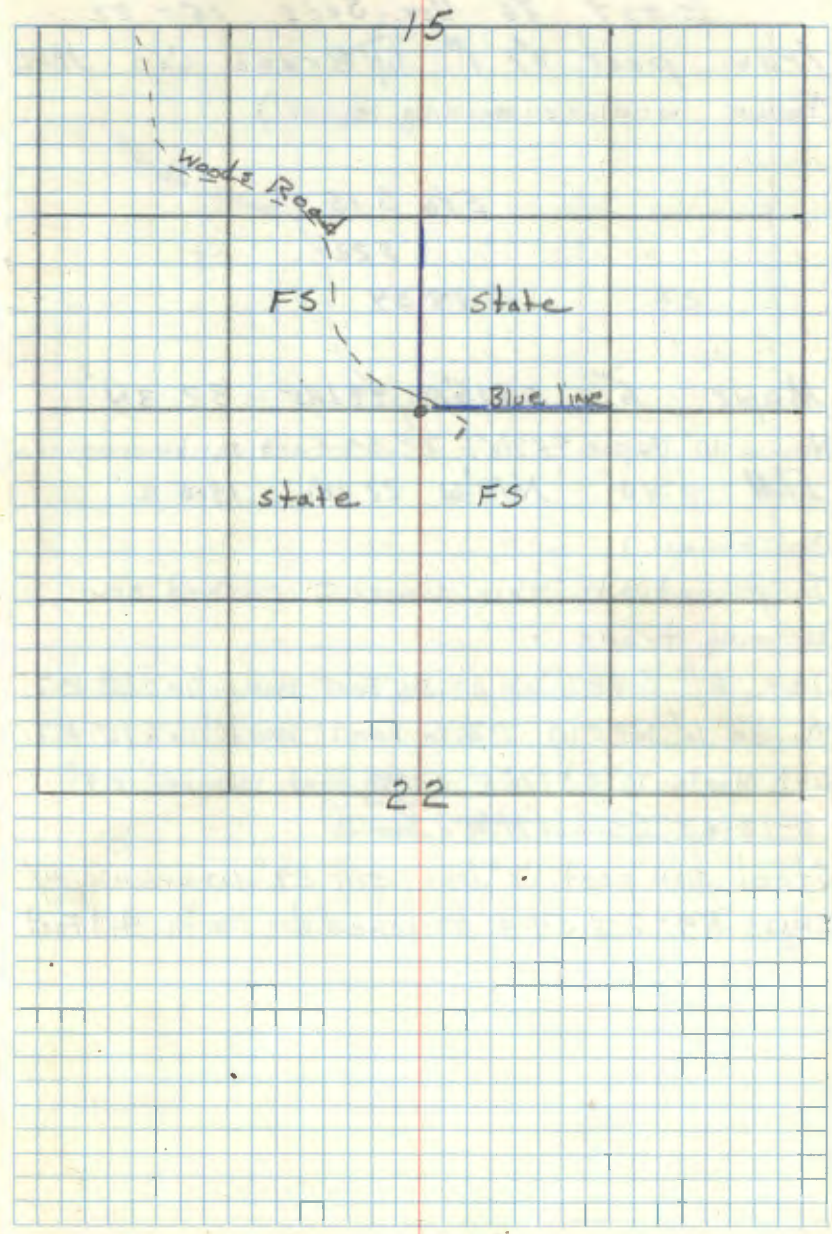
64 N-16

East $\frac{1}{16}$ Cor. Sec's 15-22

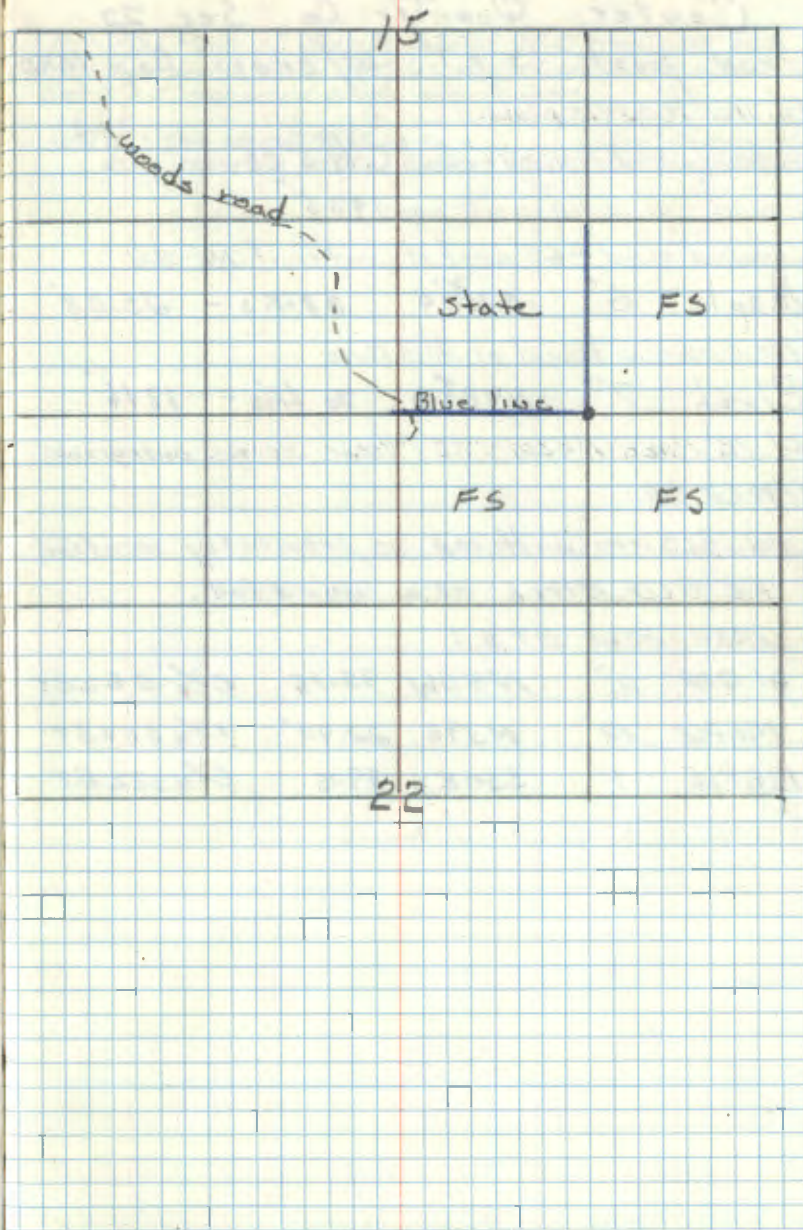
65 P-15

Center Quarter Cor Sec. 22.

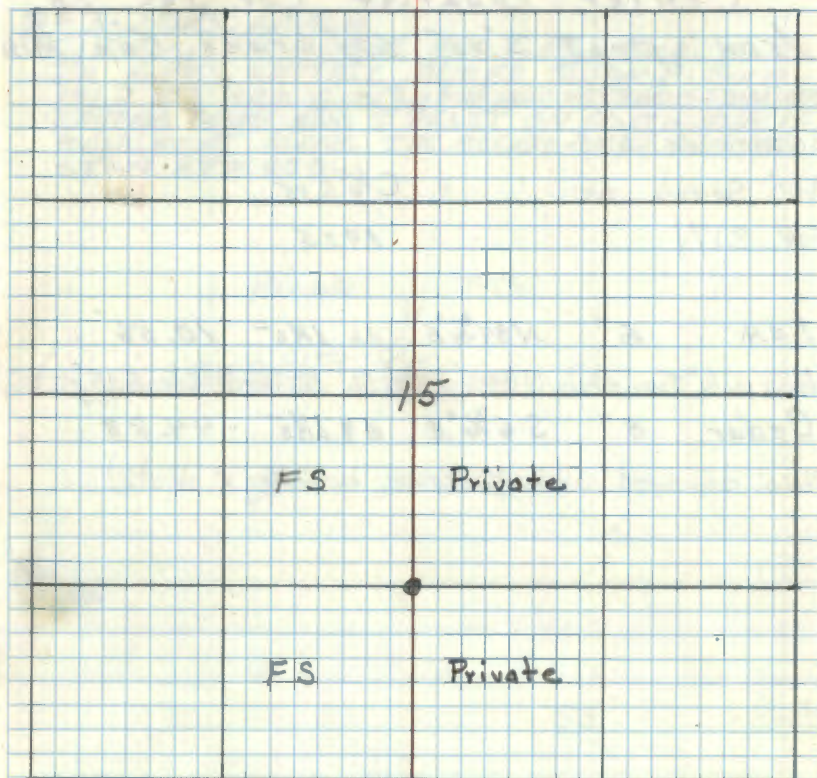
70. h-15

Center Quarter Cor. Sec. 15.

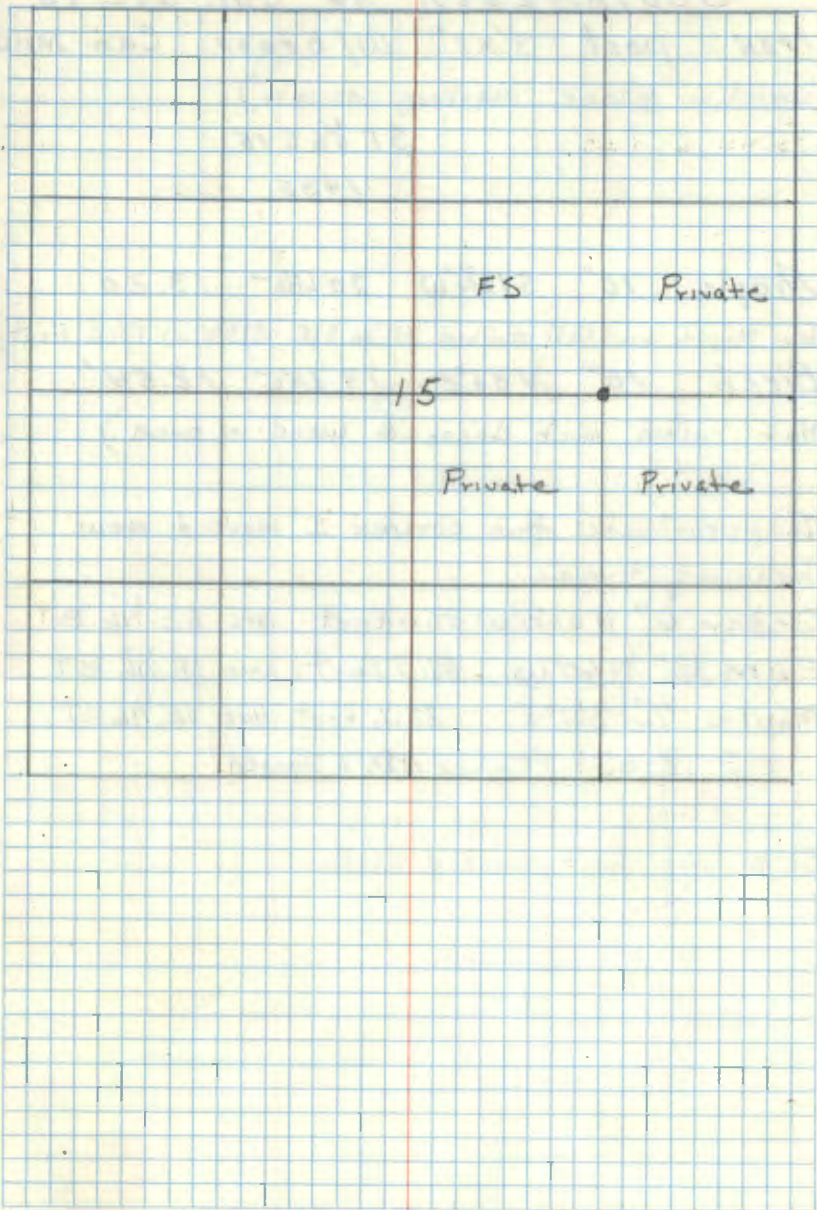
22 M-16

South East $\frac{1}{16}$ Cor. Sec. 15

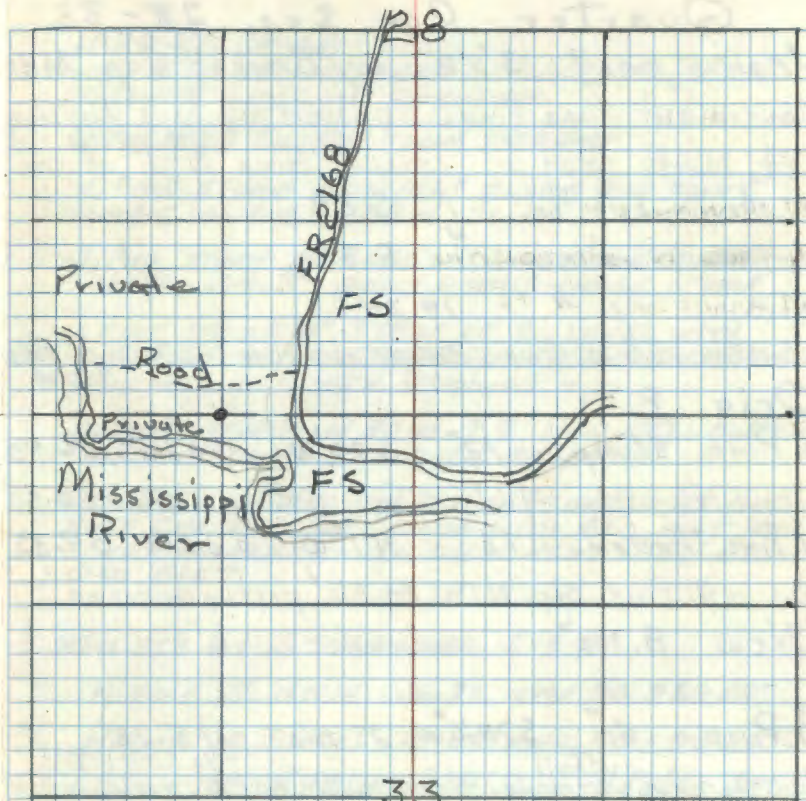
MONUMENT WITNESSED BY:

R. PINE (NEW) 25" S15°E 54.44 Ft ES & MKD W $\frac{1}{6}$ S33 BT
