Vicinity Map and Subdivision of Section 20,
Township 143 North, Range 25 West, 5th P.M.

CERTIFICATE OF SURVEY
A Boundary Survey in the
SE1/4 of the NW1/4 and SW1/4 of the NE1/4
of Section 20, T143N, R25W
for Dale Woodard

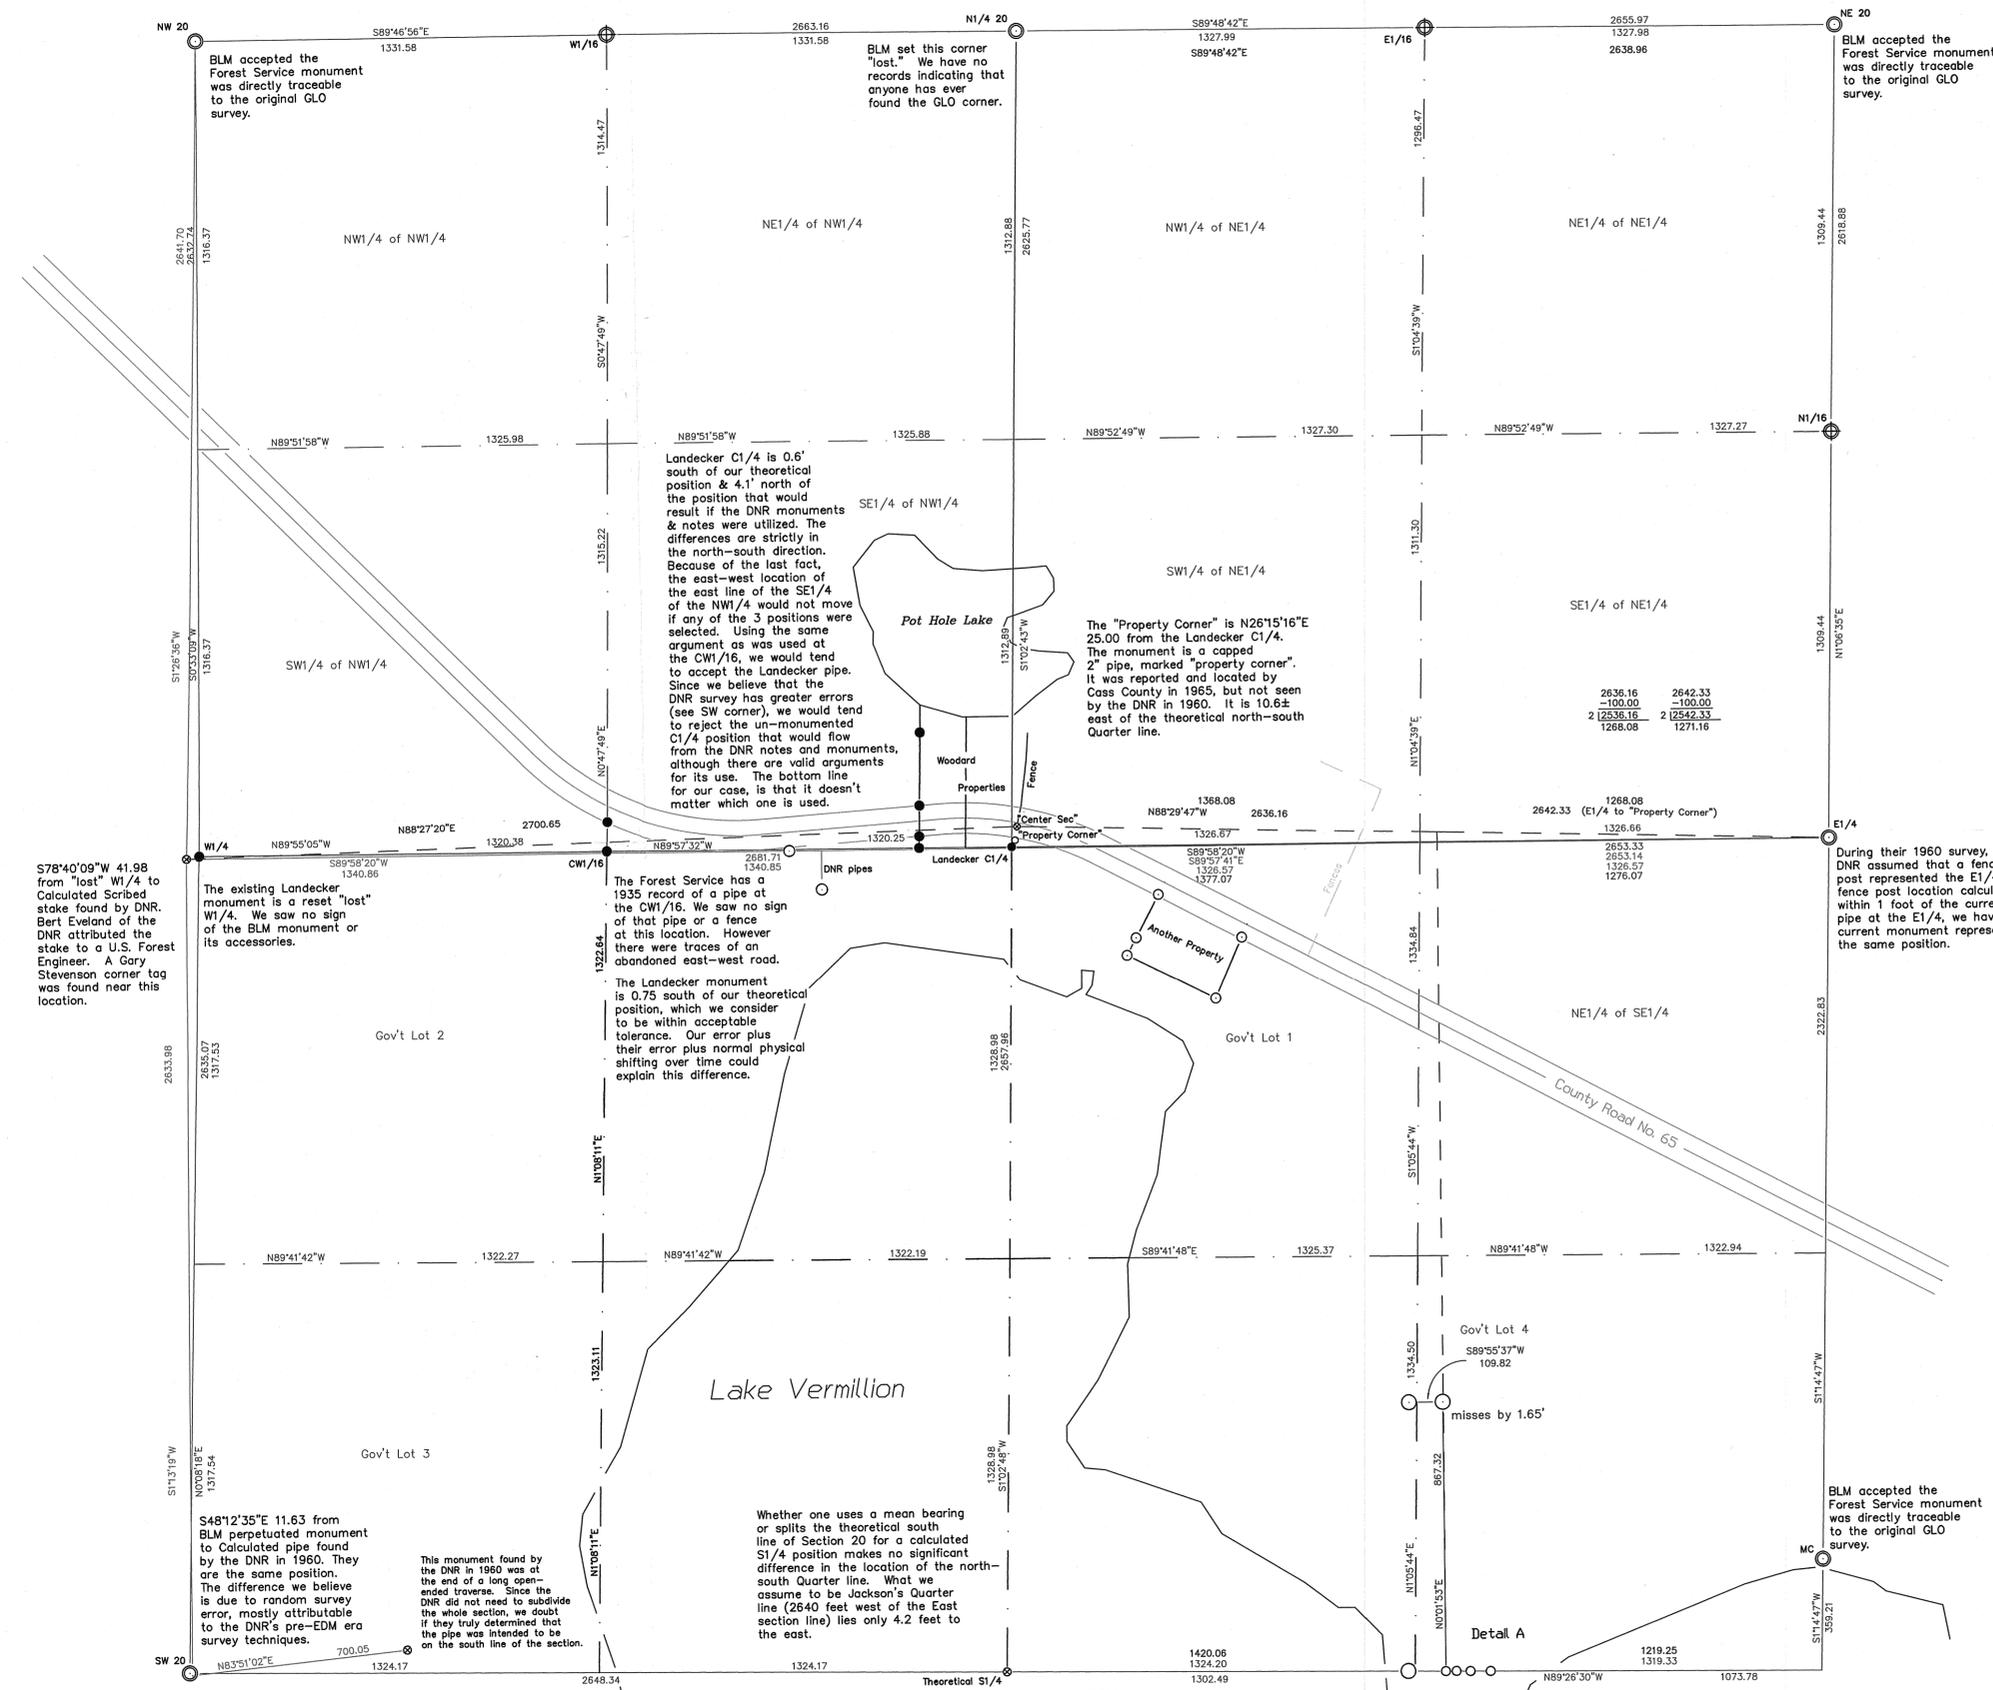
We are uncertain about the origin of the "Big C1/4." In 1960, Bert Eveland mentioned a previous Bill Spain survey in the section, so that's one possibility. It falls on the extension of a fence line that appears on Forest Service air photos from 1939 to 1959. The south end of that fence may have been removed by the 1965 re-alignment of Hwy 65. We don't know if the fence was constructed from the pipe or vice versa. The "Property Corner" is also less than 2 feet from being exactly 2640 feet from the pipe at the E1/4, which dates from after 1960 (see E1/4). That fact could lead to speculation that it was simply set at 2640 feet west of the fence post at the E1/4, from the DNR notes and monuments. Whether West was determined by an existing fence line is unknown since occupation in the S1/2 of the NE1/4 & the N1/2 of the SE1/4 has been

(re)configured to Hwy 65. There are several small parcels between the lake and the road just to the east of the C1/4. Our analysis is inconclusive as to whether the pre-1965 pipes which define their boundaries bear any relationship to either C1/4 monument. Finally F.C. Jackson monumented the E1/16 on the south line of the section and monumented the E1/16 line. We strongly suspect that Jackson used the "Center Sec" in 1970, but further suspect that he dropped a 100' station between that monument and the E1/4. Although his monumented E1/16 line would probably remain controlling inside the SE1/4, it appears to be 50 feet east of its intended position & therefore of little use in dealing with issues within the NE1/4 and NW1/4.

During their 1960 survey, the DNR assumed that a fence corner post represented the E1/4. As their fence post location calculates to within 1 foot of the current iron pipe at the E1/4, we have assumed the current monument represents essentially the same position.
