CORNER  
RESTORATION  
T 146 N R 30 W

CORNER REST. T 146 N R 30 W

USFS

T146N R.30W

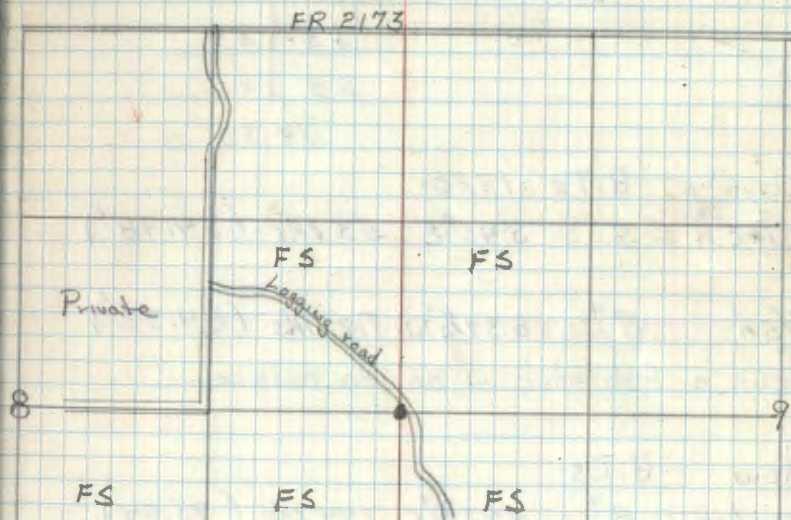
Steel sign post 72" long set 24" in ground  
w standard signs 54-4 attached due South  
3.35 feet.  
STEEL SIGN POST 72" LONG REPLACED BY  
8' STEEL SIGN POST DUE NORTH 1' FOOT  
W/FS. SIGN 54-4 ATTACHED.

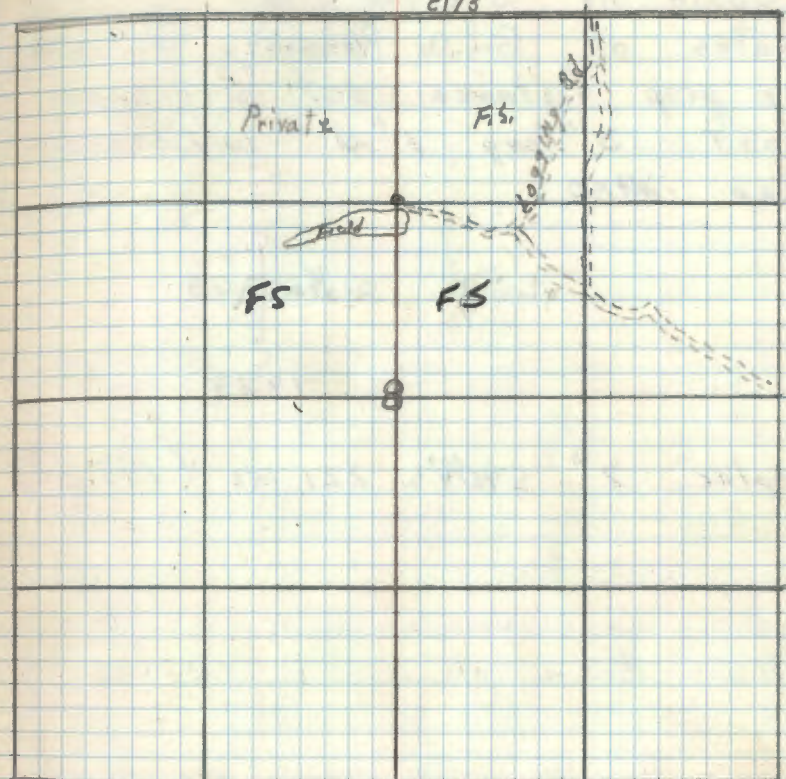
F-7

Cedar post 4x4x72 inches, penta-treated  
& w/ red top set due West w/ FS standard  
signs 54-2 & 54-4 attached 2.0 Feet

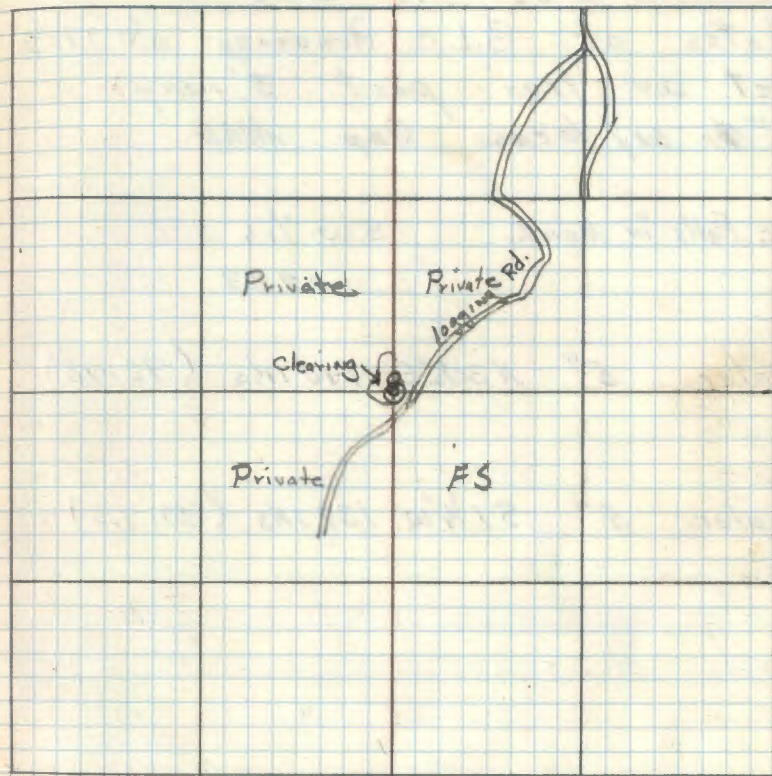
G-7

8/25/92 CK  
FL 2" IRON 3" ABOVE GROUND - IN GOOD CONDITION  
69' WEST OF FR # 3441  
PLACE FSLP ON 13" W. PINE - ON EAST SIDE OF NE-SW ROAD 79' TO COR.

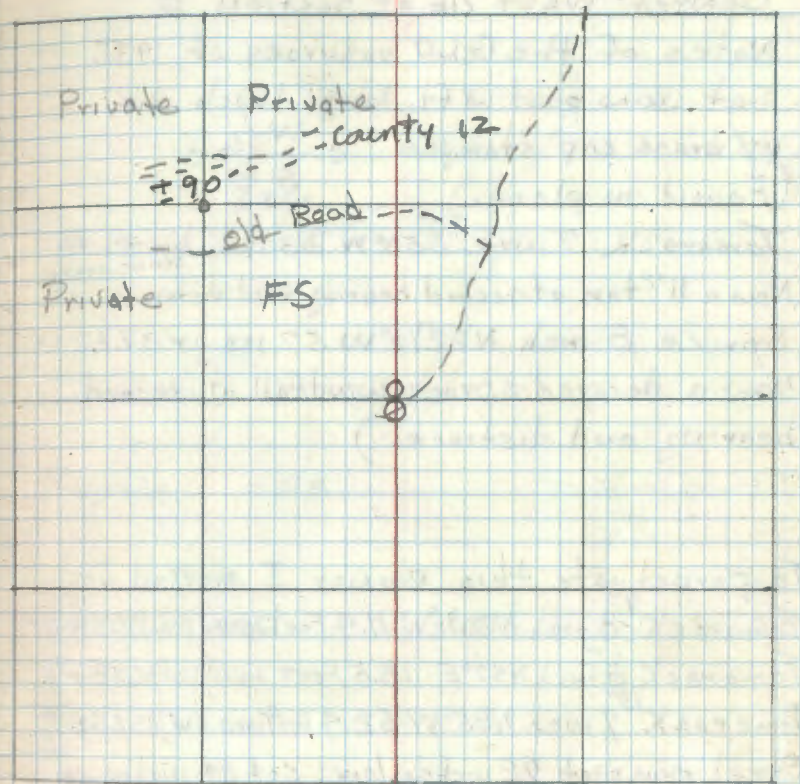
2/1/93 - MKD. New BT - MAPLE 8" S 25 W, 30.03  
Scribed, Tied & Painted.  
Set 8" steel sign posts South 4.0 and  
East 3.8' with both signs attached  
L.T.S. East & South (1993)

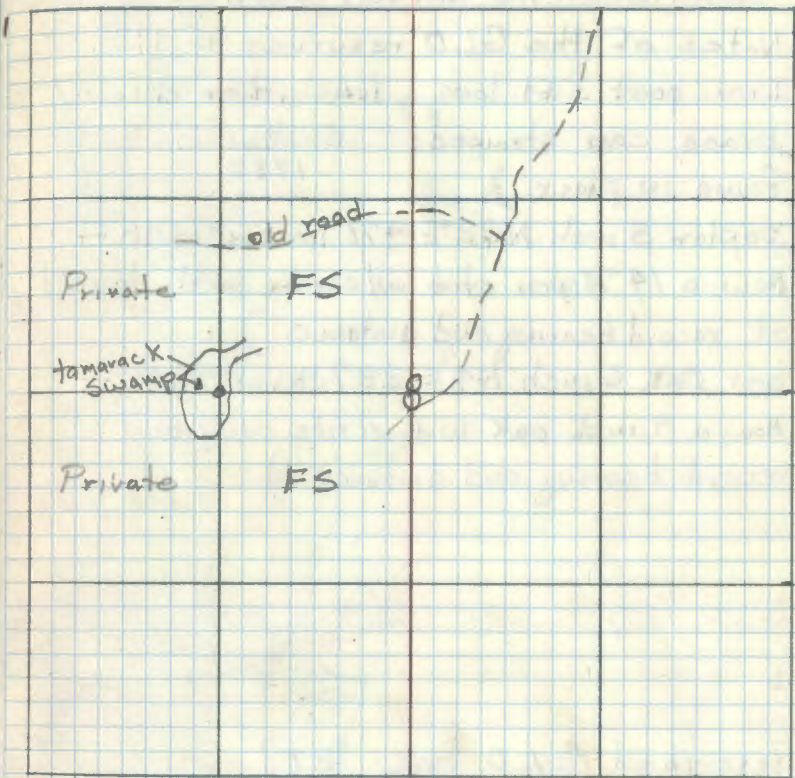
2/9/63 - set 8' steel sign posts north 3.22 & south 4.05 with both signs attached. L.T.S. north & south (1993)

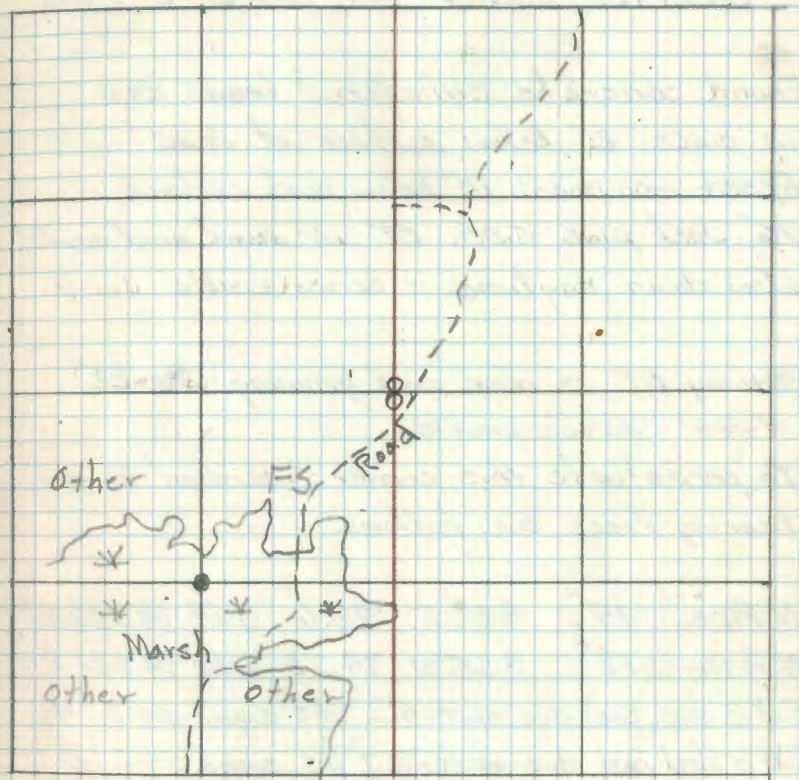
Set 8' steel sign posts as reference objects:  
NORTH 4.5 } Both signs attached  
EAST 3.2 }  
540W 4.5 Land survey sign.  
Line to standard north

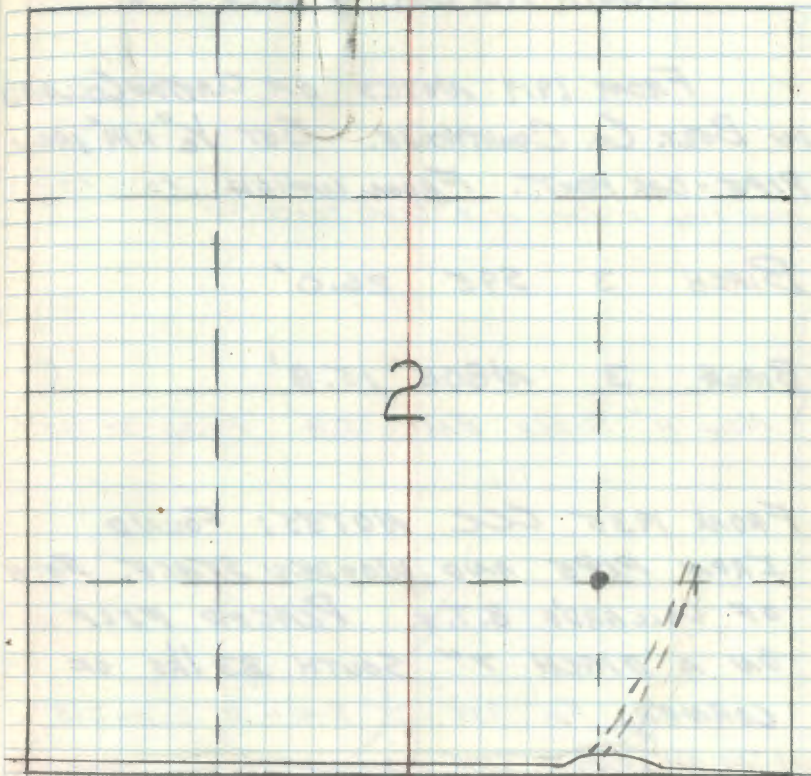
CORNER IS AT EDGE OF BRUSH SWP AND  
ASPEN-BIRCH HIGHLAND - APPROX 60' NORTH OF BLK SPRUCE  
AND J. PINE STAND - APPROX. 12 CHS WEST OF TAG ON  
10" ASPEN ON WEST SIDE OF NE-SW WOODS TRAIL  
SWP - SOUTH - EAST 1 SW - ASPEN RIDGE NE-W-NW

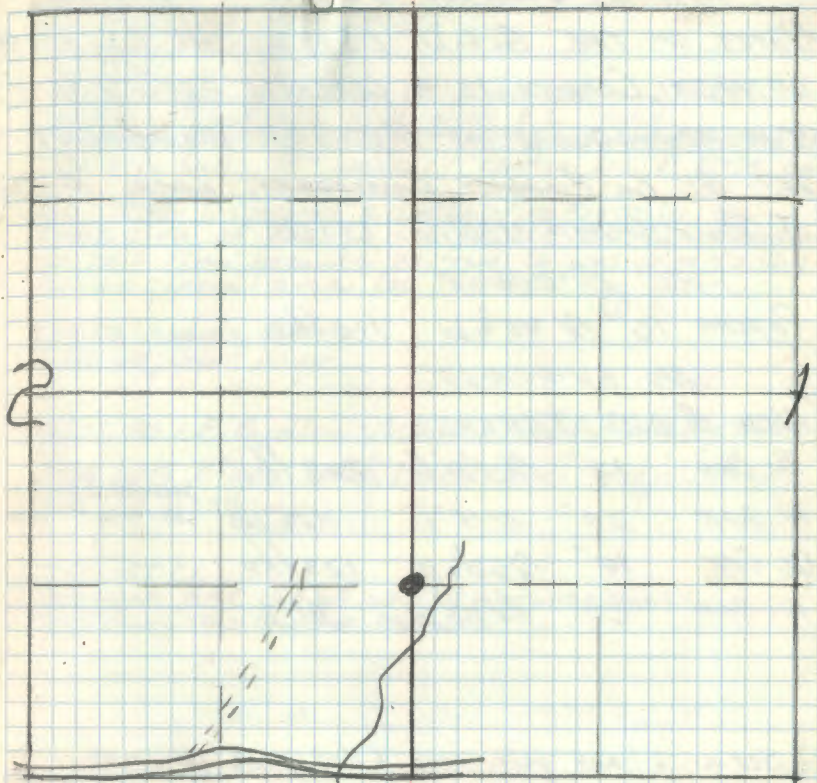
CORNER IS AT SE CORNER OF LOWLAND BRUSH  
SWP. AND ASPEN-BIRCH - HARDWOOD RIDGE TO SOUTH OF  
IRON. CORNER IS APPROX. 8 CHS. EAST OF FSLP ON 13"  
ASPEN ON WEST SIDE OF NE-SW WOODS TRAIL.  
CHAINED SWP TO SEC. COR. - TIES SOUTH ACROSS ASPEN  
RIDGE 220' ENT. CREEK BOTTOM - 283' E OF CREEK - 460' LEAVE  
CREEK BOTTOM IN ASH SWP ENT. ASPEN - 600' ENT. J. PINE-  
ASPEN

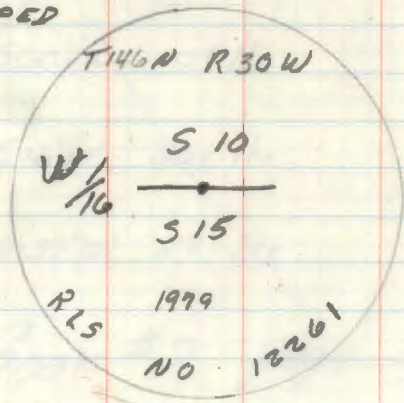
CORNER MONUMENT IS A 60" X 2" CONCRETE  
 FILLED, GALVANIZED STEEL PIPE WITH BRASS  
 TABLET STAMPED

FROM WHICH BEARS:

ASH 12" N29 E 109.93 MKD W  $\frac{1}{16}$  S15 BT
