CERTIFICATE OF LOCATION OF GOVERNMENT CORNER

NO. 15 MEANDER Corner of Section 35, Township 141, Range 27, 5 P.M.

STATE OF MINNESOTA, County of CASS

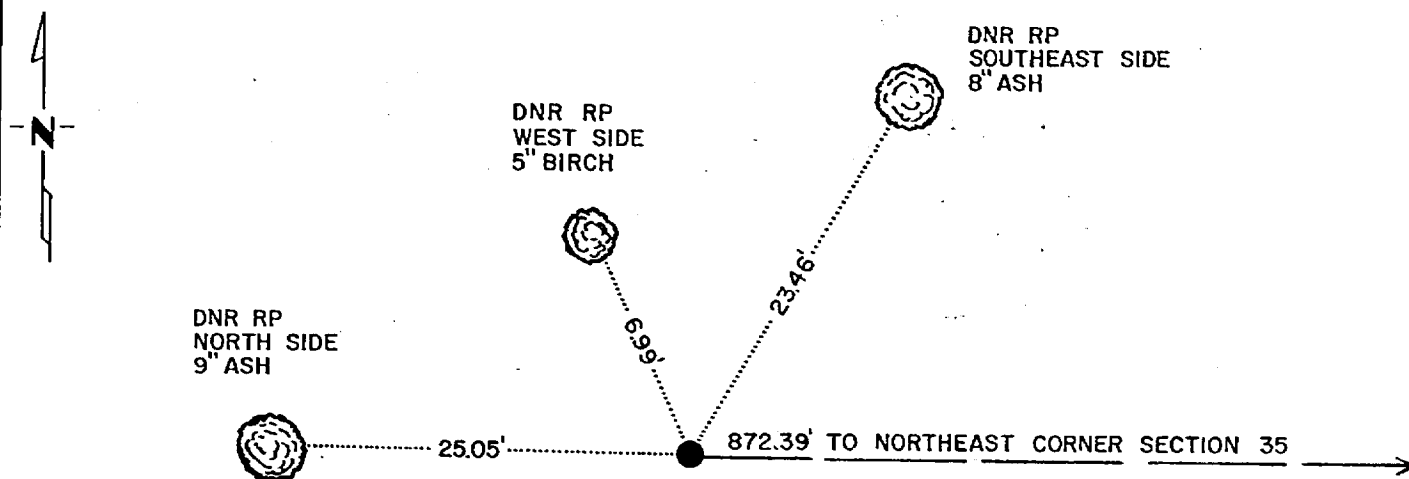
SKETCH OF REFERENCE TIES

At the corner location shown on the sketch:

- On _____ found a _____
DATE
- left monument as found, lowered monument, removed monument (explain)
- On FEB 12, 1980 placed a CAST IRON MONUMENT FLUSH 76' EAST OF LAKE BANK
DATE

Searched area of the corner and found a 3/4" I.P. about 18' from the lakeshore and 43' north of the remains of an old east-west fence. Fence is just a few feet into woods on north edge of what appears to be a garden. Followed fence to east for about 300'. Could find no evidence of fence from there to east. Appears fence may have been built to protect a garden spot. Found many rocks along lake bank. One at lake end of fence is especially large. Area to southeast of large rock is garden. Talked to Mr. Vern Vineski, owner of land to north. He bought his land in 1957 and hired Harold Curo to survey his south line. Curo had spent some time on the survey, but never came back and finished it. Vineski was of the opinion that Curo had set the 3/4" I.P. as a temporary point and never had determined the true corner. Mr. Vineski has assumed the fence to be his approximate boundary.

Assumed the corner to be lost. Reestablished it at a proportionate distance and on line between northeast and northwest section corners.
