U. S. Department of Agriculture  
FOREST SERVICE

*Chippewa* NATIONAL FOREST

CORNERS OF THE PUBLIC SURVEY

T. *142N* R. *28W* S. *5* Mer.

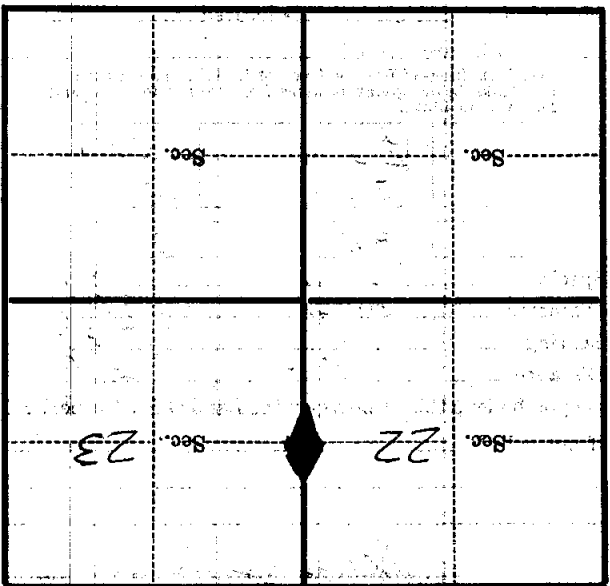
(Make sketch of topography near Corner)

Found in cedar swamp.  
An old blazed line runs  
approximately North & South  
along thru this corner

From which this Corner bears  $N13^{\circ}W$

side of Cedar

tree 6 inches diameter, on the North

Metal Location Poster is on a Cedar
