U. S. Department of Agriculture
 FOREST SERVICE

Chippewa NATIONAL FOREST

CORNERS OF THE PUBLIC SURVEY

T. 147 N R. 31 W 5th P. Mer.

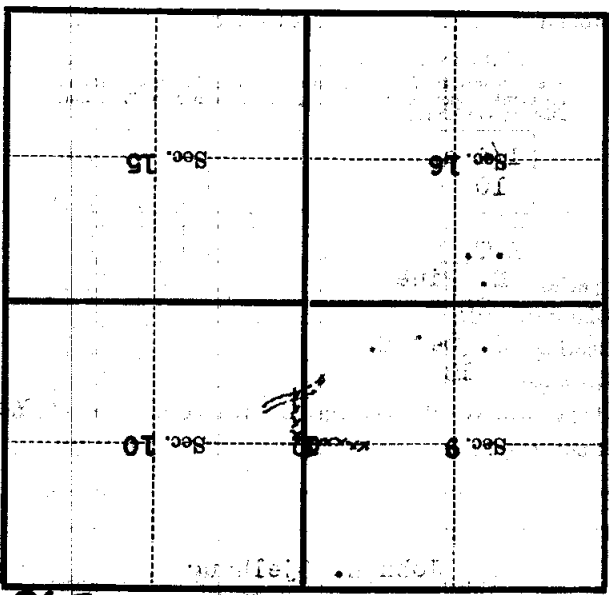
(Make sketch of topography near Corner)

0.18 chains distant.

From which this Corner bears N. 54* W.

side of tree

tree 20 inches diameter, on the N.W.

Metal Location Poster is on a N. Pine
