CERTIFICATE OF LOCATION OF GOVERNMENT CORNER

Index No.: J-15 NORTH QUARTER Corner of Section 15, Township 133N, Range 30W, 5TH P.M.

STATE OF MINNESOTA, County of Cass

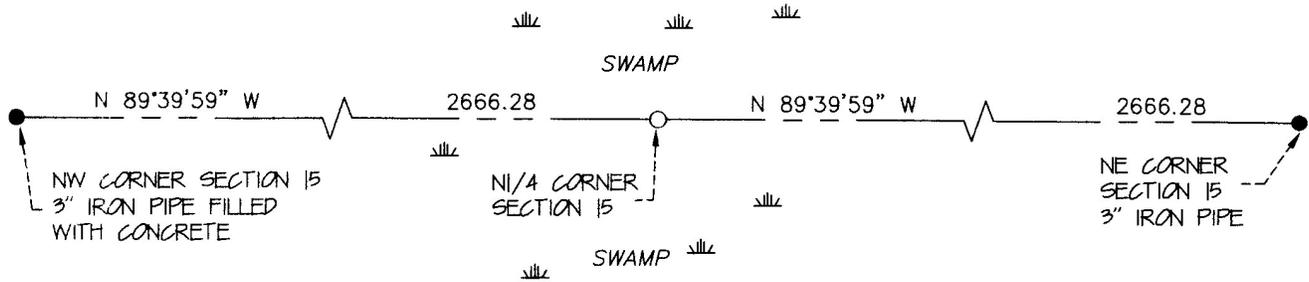
SKETCH OF REFERENCE TIES

- On _____ found a _____ Nothing
 (Date)
- left monument as found, lowered monument, removed monument (explain)
- On 4/12/2023 placed a 1/2" x 30" Iron Pipe W/ RLS Cap# 59285 in swamp at lost position.
 (Date)

NOTE: POSITION FALLS IN SWAMP
 NO SUITABLE TIES IN AREA

- 2023 Arro Land Surveying of Brainerd found no monument at the quarter corner position while conducting a survey in the Northwest Quarter of Section 15. There were remnants of a fence found to the north of the corner position. Based on the above surveys and monumentation found in said NW1/4, a 1/2 inch iron pipe with RLS cap # 59285 was placed at the lost position . Ties are shown on the face of this certificate.**
