T. 142 R. 30 M. 5th Coordinates: X \_\_\_\_\_ Y \_\_\_\_\_  
E' 4 21 Corner common to sections 21 & 22

EXISTING SURVEYS

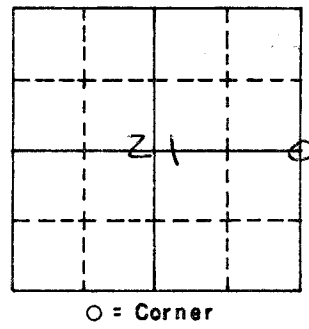
**Evidence of Subsequent Corner Restoration Found**  
 Year of search \_\_\_\_\_ By \_\_\_\_\_  
CERTIFICATE - BILL OKERMAN - 1965  
Found GLO monument in good condition.  
8" Ash S62E 25.3'; 7" Ash S19W 24.4'.
