T. 143 R. 26 M. 5TH Coordinates: X \_\_\_\_\_ Y \_\_\_\_\_  
E 1/4 Corner common to sections AND 6-143-25

EXISTING SURVEYS

C-25

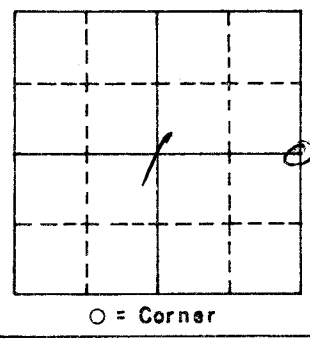
Monument SET 24" COPPER WELD 6" BELOW SURFACE W/ COPPER CAP  
T143N  
R 26 W R 25 W

Species	<u>ALUM POST W/ CAP</u>	<u>ALUM POST W/ CAP</u>	<u>BLM 1976</u>
Diameter	<u>2 1/2 x 28"</u>	<u>2 1/2 x 28"</u>	
Bearing	<u>N 44 E</u>	<u>N 24 W</u>	
Distance	<u>61.8'</u>	<u>55.8'</u>

Monument Found copper weld monument down 0.5', 3' E. of E CR #158. Also 1976 witnesses. Add the following

6" Spruce N 76° W, 90.34\*

P. Pole S 77° W, 35.42\*
